# Intel® 80219 General Purpose PCI Processor

## Specification Update

*July 2004*

Document Number: **274020-002**

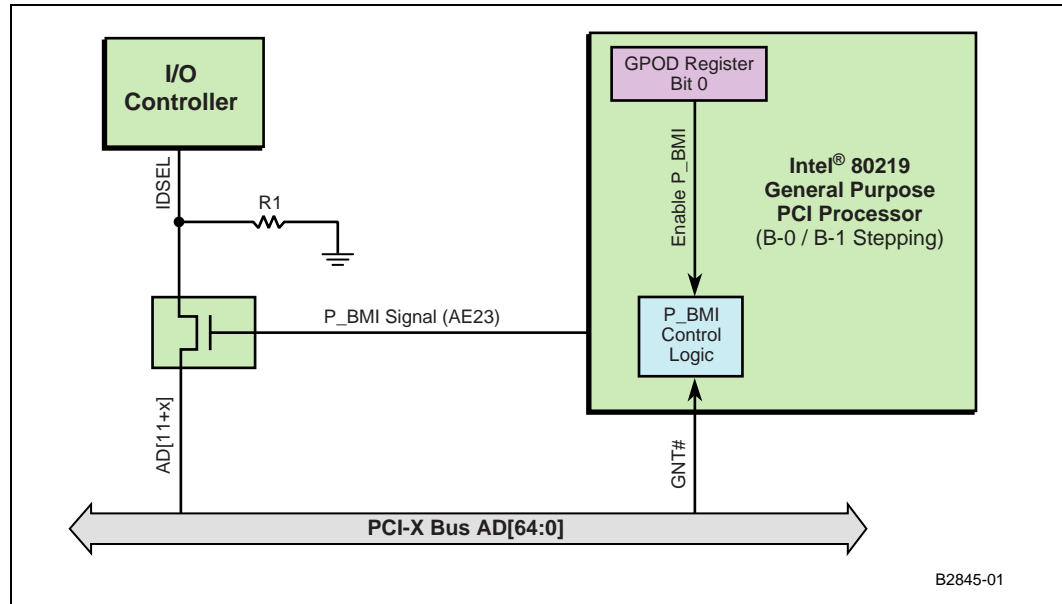
**Figure 2. Intel® 80219 General Purpose PCI Processor P\_BMI Signal Implementation for Intel® 80219 General Purpose PCI Processor B-0/B-1 Stepping**

The P\_BMI (AE23) signal has been added to the Intel® 80219 general purpose PCI processor. This signal replaces, using an external GPIO pin for Initialization Device Select (IDSEL) control of an I/O device during host configuration cycles.

**Note:** The host BIOS does not require any modifications to accommodate this implementation. All the responsibility for I/O device configuration and resource falls to the 80219 firmware.
